From: Bill Goodenough <BGoodenough@ecww.org>
Subject: St. James estimates
Date: September 20, 2011 5:52:17 PM PDT
To: Terry Kylo <terry@terrykylo.com>
Cc: Joan Anthony <JAnthony@ecww.org>, Greg Rickel <GRickel@ecww.org>

RE: **St James, Sedro Woolley
Structural Repairs**

**STRUCTURAL EVALUATION FOR
ST. JAMES EPISCOPAL CHURCH
SEDRO-WOOLLEY, WA**

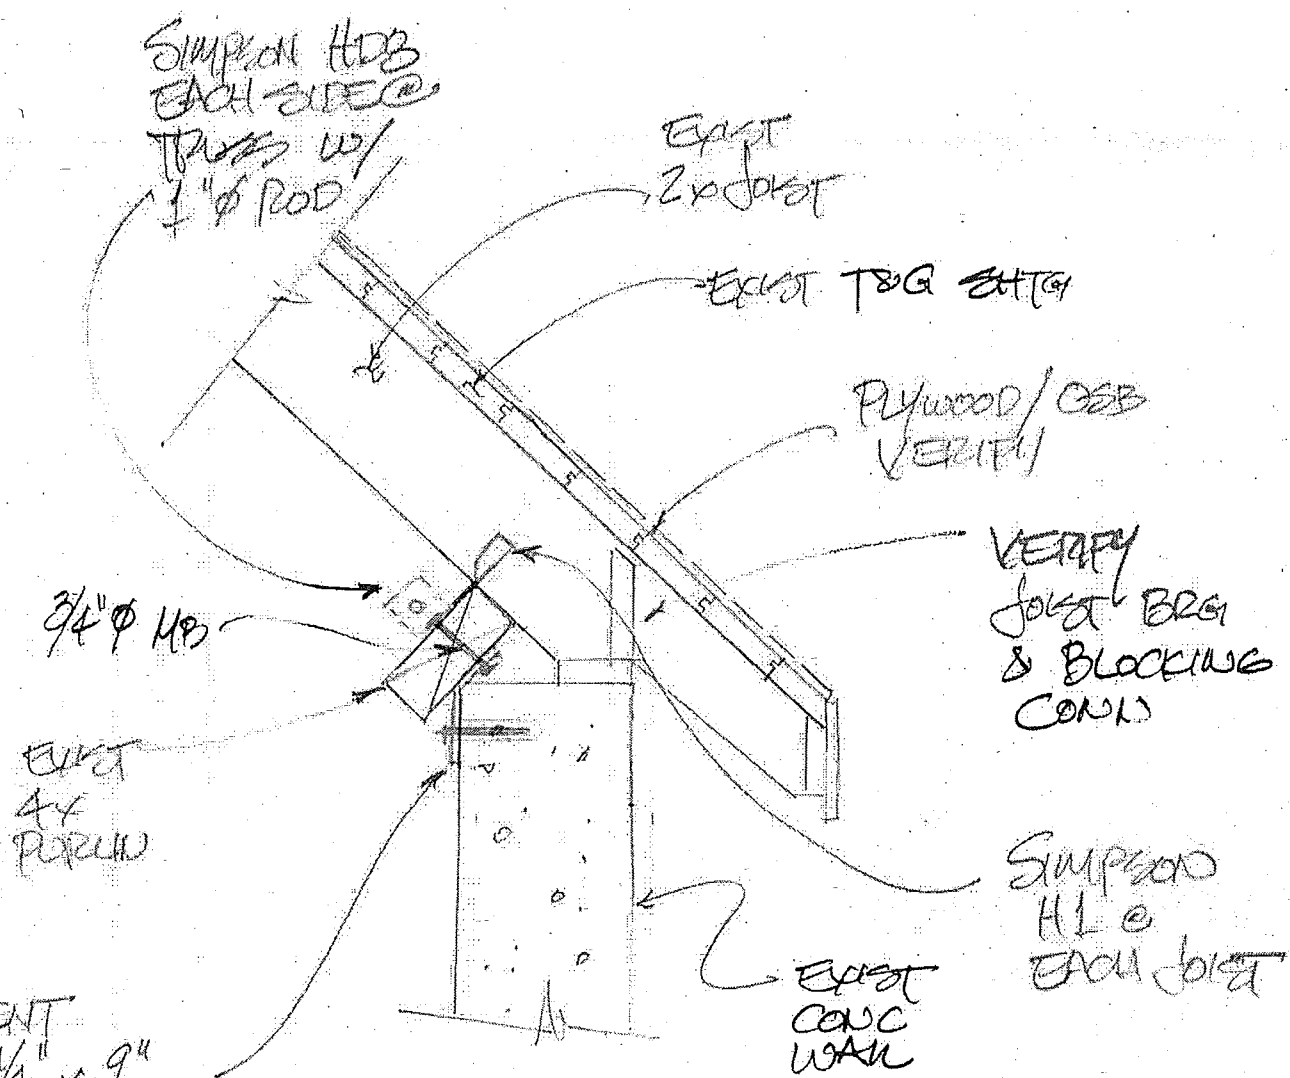
(A) DETAIL
 1" = 11'-0"

I would like to review the logistics of detail "A" prior to construction as I am not sure that this detail can actually be constructed as drawn. In order to get the bolts thru the 4x member I have assumed the 4x member would need to be removed and re-installed. A bit of brainstorming would be helpful in this to see if we could come up with an alternate detail to avoid a lot of electrical removal and re-install.

STRUCTURAL RECOMMENDATIONS		
Item	Structural Concern	Recommendation
1	Concrete bearing walls that are dependent on the diaphragm for lateral support for out-of-plane forces are not adequately anchored. In a major earthquake, there is potential for the floor and roof to separate from the wall if not adequately tied together.	Provide positive anchorage between the concrete walls and the roof structure with drilled in anchors and steel straps nailed to the floor and roof framing and sheathing (see Sketch A and B).
2	Diaphragm connections to exterior concrete shear walls are deficient. The absence of a positive connection between the diaphragm and shear walls is a gap in the lateral load path that will limit the ability of the diaphragm to transfer lateral forces to the shear walls.	Provide shear connections consisting of metal clips, blocking and edge nailing at floor and roof to wall connections (see Sketch A and B).

- Install wall connectors to 4x per detail "A"
- Install truss connectors per detail "C"
- *Painting by owner*

BENT
 R 1/4" x 9"
 w/(2) 3/4" φ THREADED
 RODS - EPOXY EMBED 6" INTO
 @ 32" ON (TYP)

NOTE: PROVIDE
 SIMILAR CONN @
 NORTH & SOUTH
 WALL w/ NEW
 BRACKING
