From: Bill Goodenough <BGoodenough@ecww.org>
Subject: St. James estimates
Date: September 20, 2011 5:52:17 PM PDT
To: Terry Kylo <terry@terrykylo.com>
Cc: Joan Anthony <JAnthony@ecww.org>, Greg Rickel <GRickel@ecww.org>

RE: **St James, Sedro Woolley
Structural Repairs**

**STRUCTURAL EVALUATION FOR
ST. JAMES EPISCOPAL CHURCH
SEDRO-WOOLLEY, WA**

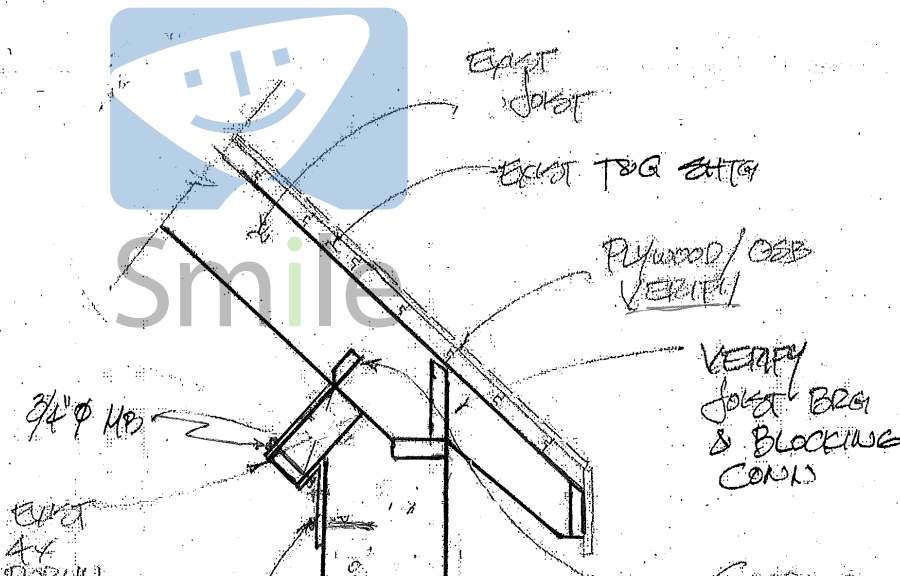
Project: St James Episcopal Church Job No: 11-238
Subject: Item #1 & 2 Sheet 2 of Name: (D)
Originating Office: Seattle Tacoma Date: 9/11/11
216-1-11

August 18, 2011 – Rick Oehmcke of PCS was OK with the proposed design – see detail A attached.
September 20, 2011 – Chad checked his steel quote. Was concerned about the bell tower steel framing that will require more detail and we need to add cushion.

I would like to review the logistics of detail "A" prior to construction as I am not sure that this detail can actually be constructed as drawn. In order to get the bolts thru the 4x member I have assumed the 4x member would need to be removed and re-installed. A bit of brainstorming would be helpful in this to see if we could come up with an alternate detail to avoid a lot of electrical removal and re-install.

- Install wall connectors to 4x per detail "A"
- Install truss connectors per detail "C"
- *Painting by owner*
